# Evaluation of modelling strategies for estimating cumulative damage on Groningen masonry buildings due to recursive induced earthquakes

Vasilis Sarhosis<sup>1</sup> · Dimitris Dais<sup>1,2</sup> · Eleni Smyrou<sup>2</sup> · Ihsan Engin Bal<sup>2</sup>

Received: 8 July 2018 / Accepted: 20 December 2018  
© Springer Nature B.V. 2019

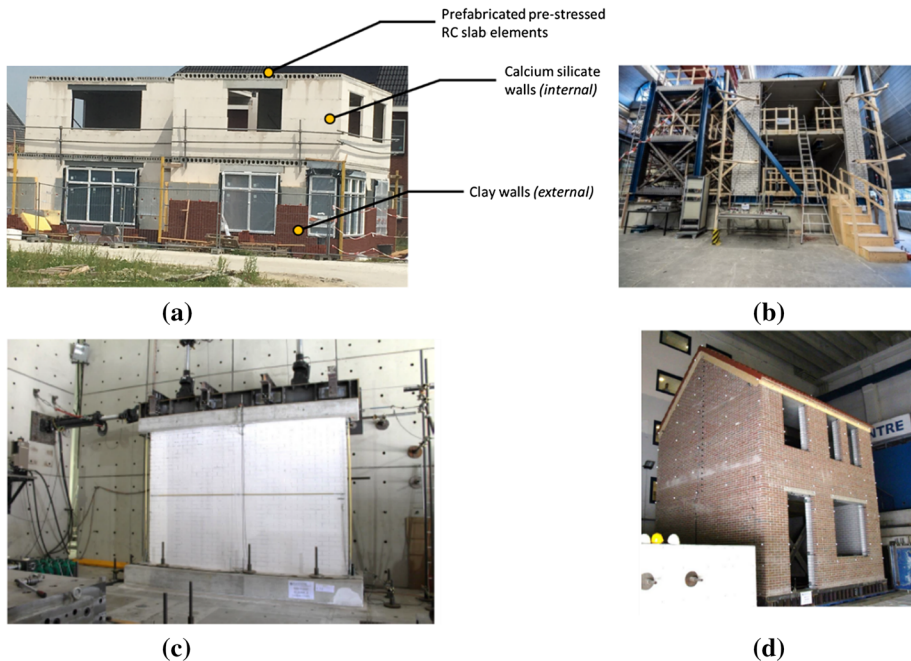
**Fig. 1** **a** Typical masonry Groningen house under construction, **b** full scale cyclic test setup for Groningen houses (Esposito et al. 2017), **c** quasi-static in-plane calcium silicate wall specimen from Graziotti et al. (2015, 2016), and **d** full-scale cavity-wall test specimen on the shake-table from Graziotti et al. (2017, 2018)

One of the walls tested by Graziotti et al. (2015) was used here for parametric analyses. It is reminded that the wall had dimensions of 4.0 m width and 2.75 m height, representing a shear-dominated wall (Fig. 1c). The specimen was left free-to-rotate on the top creating a cantilever condition. A constant vertical stress of 0.3 MPa was applied during the tests, kept fairly constant by two vertical actuators. The wall material was calcium silicate and cement mortar, representing the terrace houses with cavity walls built in the region in the post-war time. The calcium silicate layer is the internal leaf bearing the vertical loads from the slabs in the Groningen construction practice.

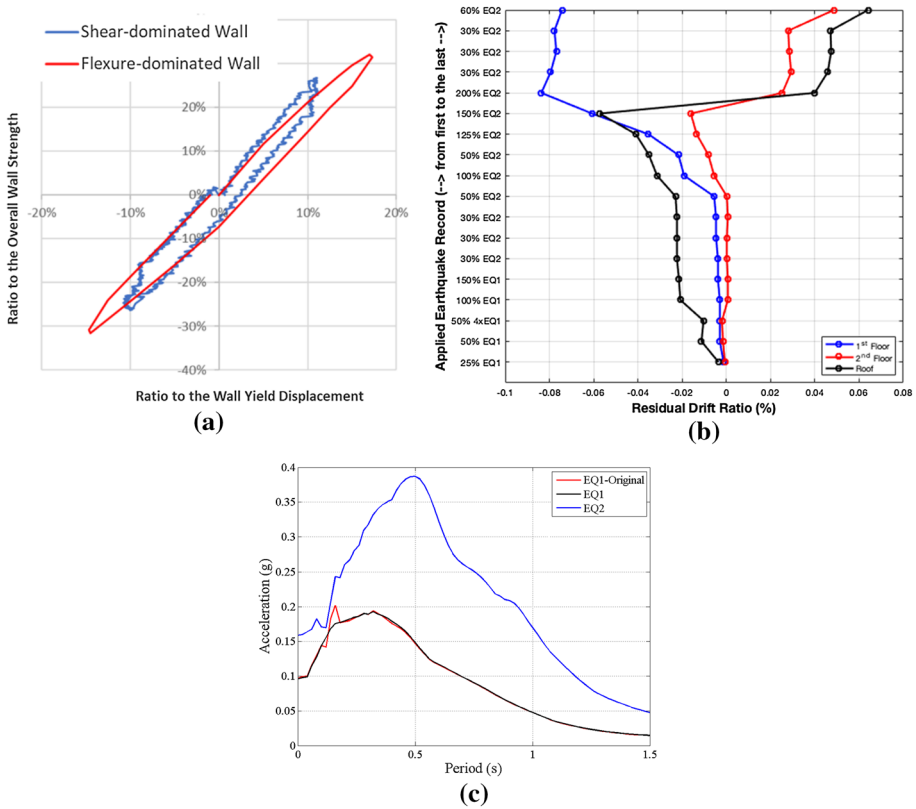
**Fig. 2** **a** First cycles from the quasi-static wall tests on calcium silicate specimens (modified from Graziotti et al. 2015), **b** residual displacements from sequential shake-table tests on the full-scale specimen (modified from Graziotti et al. 2017, where 'y' axis shows the sequentially applied earthquake records starting from the bottom, 25% EQ1, and ending with the top, 60% EQ2), and **c** the acceleration spectra of the EQ1 and EQ2 records used in the shake-table tests (taken from Graziotti et al. 2015)

In Fig. 2b the results from 18 sequential tests with varying earthquake scaling from 25 to 200% are presented. The EQ1 in this set of tests refers to an earthquake record with 0.1 g PGA while the EQ2 is a record with 0.16 g PGA (random vibration test results are removed from the original figure in Graziotti et al. 2017). The residual displacement from the sequential application of these earthquakes is not cumulative towards one direction, meaning that it changes sign during the experiments. For example, application of 150% of EQ2 resulted in 4.5 mm residual displacement at roof while the next applied record, 200% of EQ2, resulted in 3 mm residual displacement in the opposite direction. Observations on

the small pre-yield load and displacement amplitudes as discussed in this paper earlier (see Fig. 2a). In order to represent this aspect of URM structures, the first branch of the CP17 backbone has been modified (Fig. 5). The yield force of the fully elastic branch in the CP17 model is reduced down to its 1/10th (see Fig. 5c for comparison). Such an ad-hoc assumption, not relying on experimental evidence due to lack of such evidence at first hand, has been made for the sake of convenience given the parametric nature of this exercise.

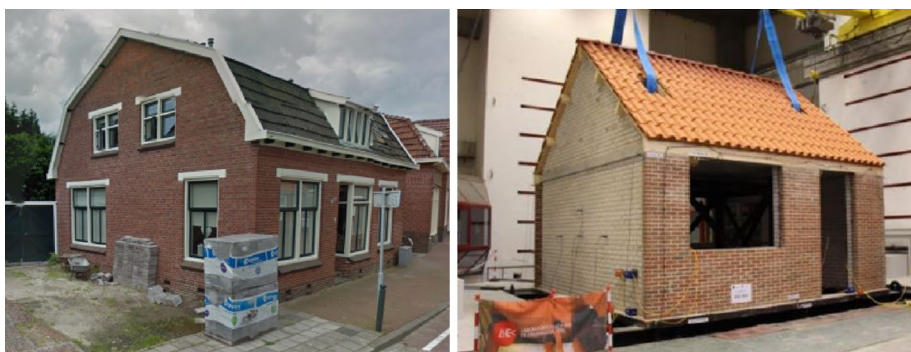
**Fig. 3** Typology buildings analysed by Mozayk (2017): Nieuwstraat 8 index building (left) and LNEC-BUILD1 (right)

Two houses of different typology (Fig. 3), one real index building and one test structure typical of real structures in the Groningen gas field, were extensively studied by several researchers for determining the vulnerability of the structural inventory and thus the seismic risk in the region (van Elk and Doornhof 2017; Crowley and Pinho 2017). The two dominant types of residential structures in the area are the terrace and detached houses. Terrace houses are unreinforced masonry buildings, typically two to three floors, constructed with cavity walls as explained before. Detached ones are the older style houses, mostly built with solid unreinforced masonry walls, still of two to three floors typically. In an attempt to derive information for the fragility and consequence model for Groningen gas field, Mozayk (2017) presents 3D analysis results of two typology buildings: Nieuwstraat 8 and LNEC-BUILD1. Nieuwstraat 8 is an unreinforced masonry detached house with timber attic and roof diaphragms, built around '40s. LNEC-BUILD1 is a full-scale URM cavity-wall house specimen tested at LNEC (Tomassetti et al. 2017). In the study by Mozayk, the two buildings were modelled by using the applied element approach (Meguro and Tagel-Din 2000) and subjected to nonlinear time-history analyses by using 11 records selected to cover a range of intensities in terms of AvgSa (Kohrangi et al. 2017), Arias Intensity (Arias 1970), PGA and spectral acceleration at 0.1 s. The horizontal component of the selected records was applied in the weak direction of these structures, while each acceleration record was imposed individually and not sequentially. Details of the modelling assumptions, as well as the analyses results can be found in Mozayk (2017).

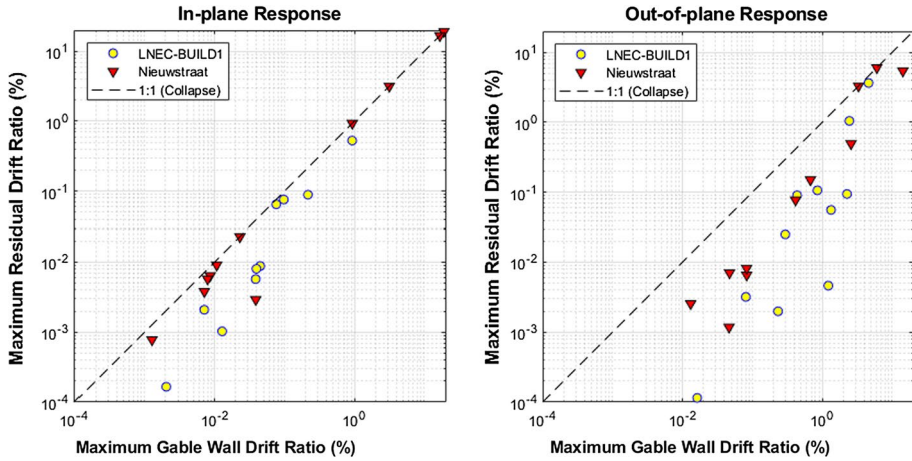
**Fig. 4** Comparison of the residual top drift ratio from each individual time history analysis versus the maximum top drift ratio attained during that analysis, based on the data taken and re-processed from Mozayk (2017)

The analyses results, the digital data of which were kindly provided by Mozayk to the authors, were presented in terms of in- and out-of-plane displacements at the gable wall level. Individual time-history analysis results were then re-processed by the authors producing plots of the residual gable wall drift ratio versus maximum drift ratio attained in the analyses for both in-plane and out-of-plane structural response (Fig. 4). Unit value

ratio of residual drift to the maximum drift manifests collapse as the structure reaches a certain excessive displacement at the end of the analysis and remains there without being able to re-centre at all. The consistently smaller residual displacements in the out-of-plane response reflect the re-centring ability of masonry walls under out-of-plane actions thanks to the vertical loads and self-weight, behaviour that is even more evident in slender walls, as supported by the very low out-of-plane residual drifts of the LNEC-BUILD1 that consists of slender cavity walls. Concluding, every individual earthquake record can induce significant residual deformations on the analysed typology buildings, suggesting that repetition of such earthquakes would lead to accumulation of damage and change in stiffness and strength characteristics of similar buildings.

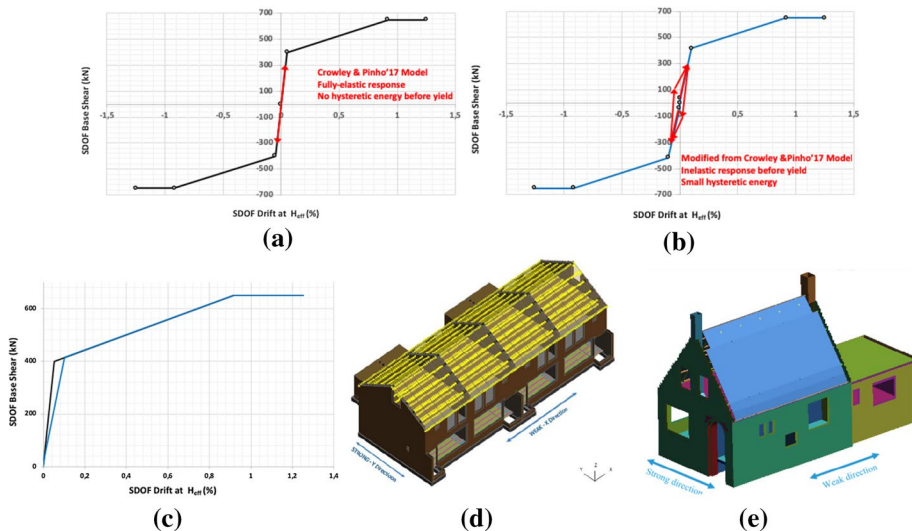
**Fig. 5** **a** An example SDOF backbone curve from Crowley and Pinho (2017), **b** modified SDOF backbone to obtain plastic deformations and hysteretic energy consumption even in attained forces smaller than the yield, **c** comparison of the original Crowley and Pinho'17 SDOF curve with the modified curve, **d** index building Julianalaan 52 and **e** index building Badweg 12 (please note that the other index building, NS8, was already shown in Fig. 3)

The parameters for the SDOF models, calibrated by Crowley and Pinho (2017) and referred to as CP17 backbone curve, had to be slightly modified for this study. If the original CP17 backbone curve was used (Fig. 5a), a fully elastic response would be obtained without any plastic deformations, residual displacements or hysteretic energy consumption when Groningen records are applied, as explained further in the paper. The initial force–displacement branch of URM response is assumed linear in the CP17 backbone curve for the sake of simplicity, however in reality the response is often nonlinear even in

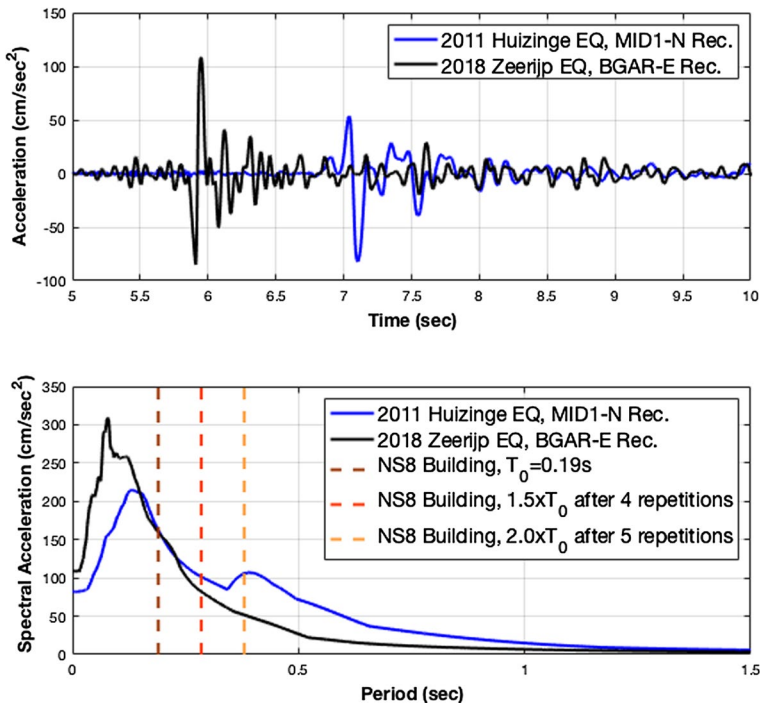
**Fig. 6** Acceleration time histories of the two Groningen earthquake records used for analyses (top), and comparison of their 5% damped elastic acceleration response spectra together with the change in fundamental period of NS8 building SDOF model (bottom)

The validation of the model was performed against the results of the experiment under cyclic horizontal in-plane load with incremental increase of the imposed displacements. The initial stiffness for the model is captured with accuracy (Fig. 11). Apart from the crack patterns (Fig. 11a, b), the cyclic response for the first three cycles have also been compared, where important parameters such as strength, unloading and reloading stiffnesses are captured fairly accurately (Fig. 11d). The hysteretic loop obtained from numerical analyses provides higher hysteretic energy dissipation by 12% (Fig. 11e) than the experiment, level that was deemed satisfactory. The match of the model to the very first cycles of the load–displacement curve is of prime importance for the purposes of this paper as the applied acceleration levels, up to 0.10 g, do not mobilize the entire hysteretic behaviour of the wall. The levels of accelerations in the analyses were up to 0.25 g initially, but this caused collapse in the walls with large opening. This is basically why the analyses results with acceleration amplitude up to 0.10 g are presented here. This is a reasonable level of acceleration considering that the highest PGA ever recorded in Groningen gas field was 0.11 g in 2018 Zeerijp Earthquake (Fig. 6).

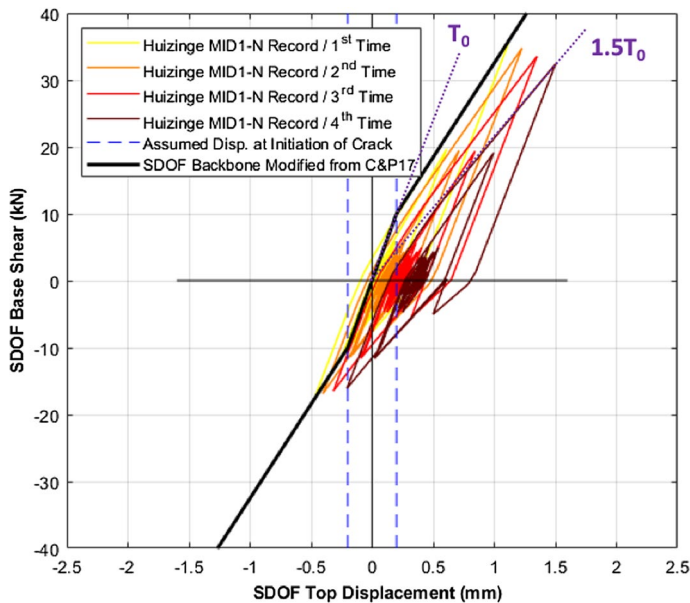
**Fig. 7** Response of the SDOF model of Nieuwstraat 8 (NS8) to Huizinge earthquake (2012) MID1 record N component sequentially 4 times, with a damage coefficient  $D$  of 0.015

found that when strength degradation is considered, the relationship between the earthquake sequence and the residual damage is not linear, in fact the damage is fast increasing as more earthquakes applied on the structure. On the contrary, this relation is perfectly linear when the strength degradation is ignored. One of the plausible explanations for the high record-sensitivity of the accumulation of damage can be the match between the dynamic properties of the structural model and of the applied record. Although the BGAR-E record from the Zeerijp Earthquake has higher PGA (0.111 g) than that of the MID1-N record from the Huizinge Earthquake (0.084 g), their elastic spectral acceleration responses are identical at 0.19 s, which is the fundamental period of vibration of the NS8 SDOF model. The SDOF fundamental period elongates as nonlinearities develop and as more residuals accumulate. An example is shown in Fig. 7 where the effective period of vibration of the SDOF model increases 50% after the same earthquake is applied 4 times. The fundamental period is doubled, for example, after the Huizinge record is applied 5 times on the NS8 SDOF. The initial and the elongated periods of the NS8 model can be seen in Fig. 6 (bottom), where the spectral demand of the Huizinge record is twice that of the Zeerijp record.

Although the exercise presented here is parametric, the assumption of a maximum damage coefficient ( $D$ ) equal to 0.015, used in producing Fig. 7, has been cross-checked. A

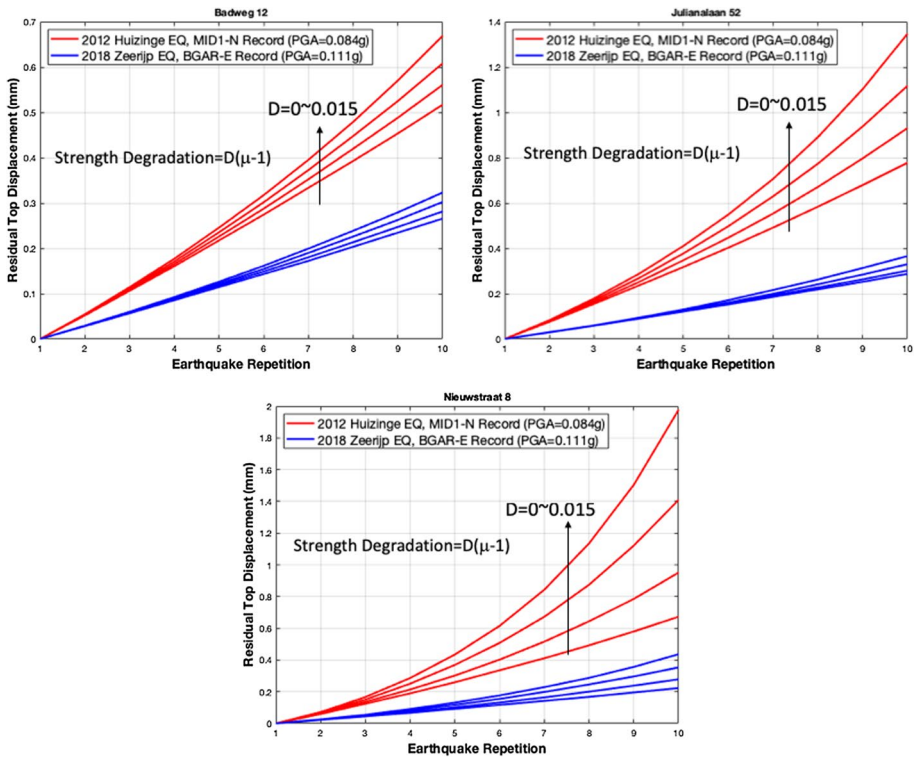
**Fig. 8** Residual top displacement of the SDOF models for 10 times repeated 2012 Huizinge (MID1-N component) and 2018 Zeerijp (BGAR-E component) records for the index buildings Badweg 12 (top-left), Julianalaan 52 (top-right) and Nieuwstraat 8 (bottom)

It is underlined that the results obtained are only parametric since there is no experimental evidence that would allow to calibrate the strength degradation of the SDOF model of those index buildings. The results exhibit accumulation of damage towards a certain direction, as well as degradation of strength with increasing number of earthquakes. Even if the exact same earthquake record is applied, the residual damage, which is the residual displacement of the SDOF system, is nonlinearly increasing. Figure 8 presents analyses conducted by applying the same earthquake record 10 times on the SDOF models for the three index buildings.

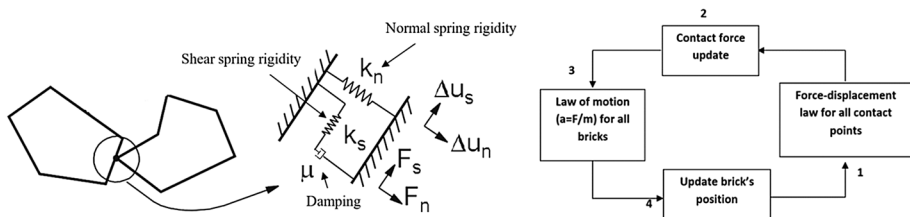
**Fig. 9** Mechanical representation of contact between blocks (left) and the simplified calculation cycle for rigid blocks (right)

In order to overcome the issues related to the use of SDOF models explained previously, detailed models were created employing discrete-element modelling (DEM) approach in UDEC software (Itasca 2011), a tool based on discontinuous modelling that can simulate the response of discontinuous media subjected to either static or dynamic loading. When used to model brickwork structures, the bricks are represented as an assemblage of rigid or deformable distinct blocks which can take any arbitrary geometry. Rigid blocks do not change their geometry as a result of any applied loading and are mainly used when the behaviour of the system is dominated by the mortar joints. Deformable blocks are internally discretised into finite difference triangular zones and each element responds according to a prescribed linear or non-linear stress–strain law. These zones are continuum elements as they are defined in the finite element method (FEM). Mortar joints are represented as zero thickness interfaces between the blocks. These interfaces can be viewed as interactions between the blocks and are governed by appropriate stress-displacement constitutive laws. Interaction between the blocks is represented either by sets of point contacts or by sets of edge to edge contacts, with no attempt to obtain a continuous stress distribution through the contact surface. The mechanical interaction between the blocks is simulated at the contacts by spring like joints with normal and shear stiffness.

As in the Finite Element Method, the unknowns are the nodal displacements and rotations of the blocks. However, unlike FEM, DEM is a dynamic process and the unknowns are solved explicitly by the differential equations of Newton's Second law of motion at all bricks or nodes and the force–displacement law at all contacts. The force–displacement law is used to find the contact forces from known displacements, while Newton's second law gives the motion of the blocks resulting from the known forces acting on them (Fig. 9). In this way, large displacements along the mortar joints and the rotations of the brick elements are allowed with the sequential contact detection and update of tasks automatically. Furthermore, DEM approach can model both static and dynamic load effects. The static solution is achieved by artificial damping similar to the dynamic relaxation method where the equations of motion are damped to reach the equilibrium state. Also, the DEM approach can employ time-stepping algorithms either in real time scale or as a numerical device to solve quasi- static problems (Itasca 2011). For a full description of modelling masonry structures using the discrete element method, the reader is referred to Sarhosis and Sheng (2014) and Sarhosis et al. (2015).

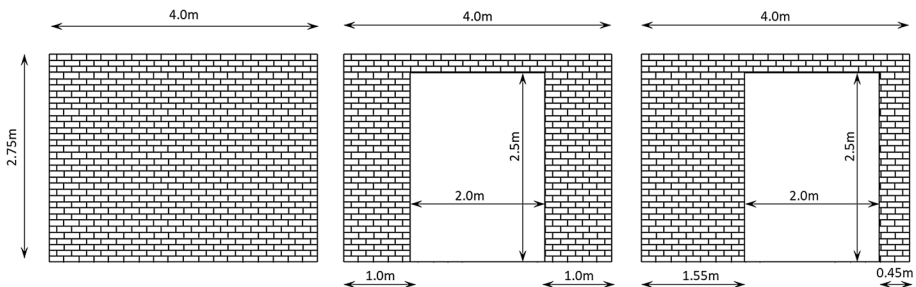
**Fig. 10** Geometric models developed in UDEC: wall panel with no opening (left), wall panel with symmetric opening (middle), and wall panel with asymmetric opening (right)

In the numerical model, the vertical edges of the wall panel were left free. Gravitational load due to self-weight was also imposed to the model in addition to vertical pre-compression equal to 0.3 MPa assigned on the top of the wall in line with the experimental set up. The mass of the system used in the dynamic analyses consists of the wall self-weight as well as of the distributed mass on the top of the wall coming from the load representing the vertical pressure. Initially, the model was brought into a state of equilibrium under its own self-weight and then the seismic loads were assigned. A geometric model to represent the wall panel tested in the laboratory was constructed in UDEC software. Each brick of the masonry wall panel was represented by deformable blocks separated by zero thickness interfaces at each mortar bed and perpendicular joint. To allow for the 10 mm thick mortar joints in the real wall panels, each deformable block was based on the nominal brick size increased by 5 mm in each face direction resulting in a model block size of 225 mm × 102.5 mm × 75 mm. A typical geometry of the wall panel developed in the software is shown in Fig. 10.

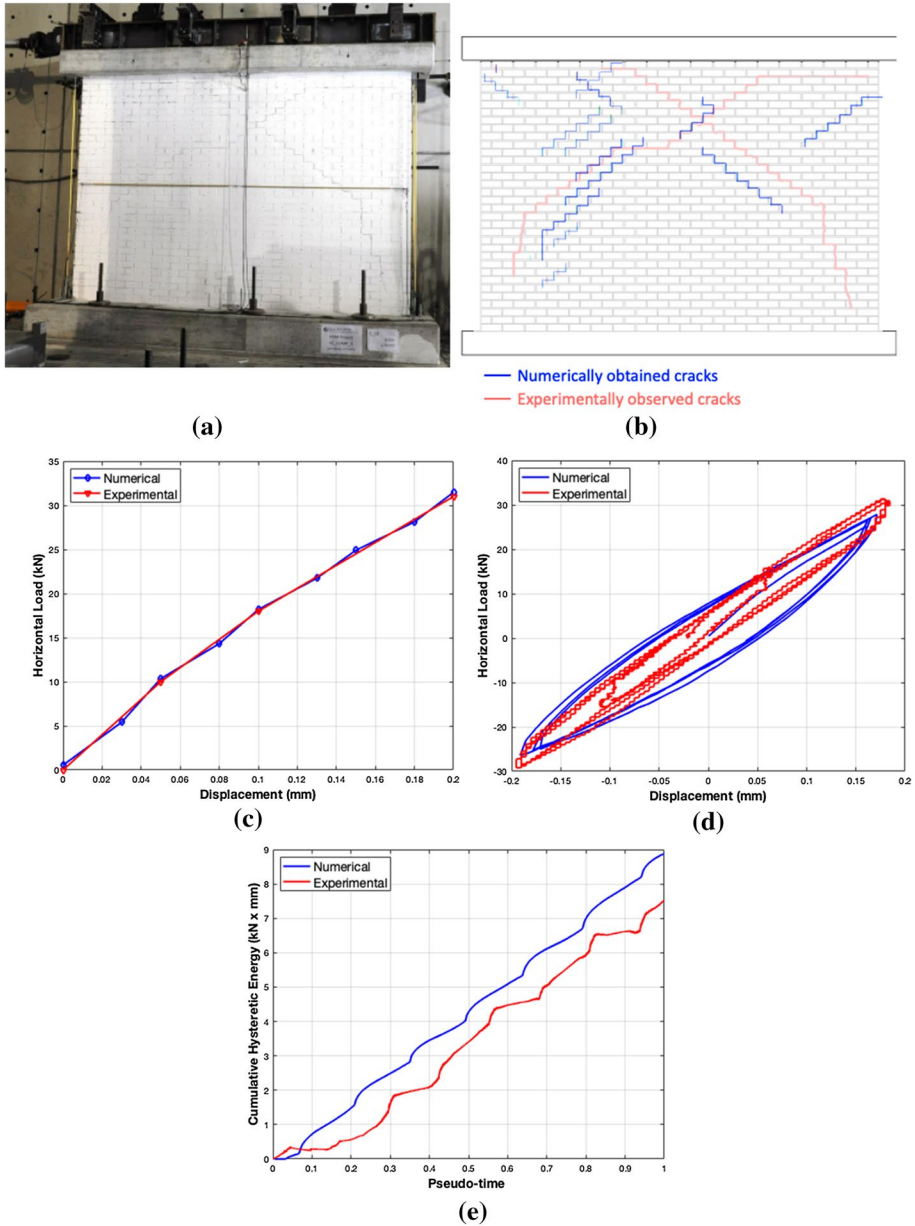
**Fig. 11** Comparison of experimental against numerical results in terms of **a**, **b** crack pattern observed, **c** the initial stiffness for the squat wall test, **d** the first loading cycles, and **e** cumulative hysteretic energy for the first cycles shown in **d**

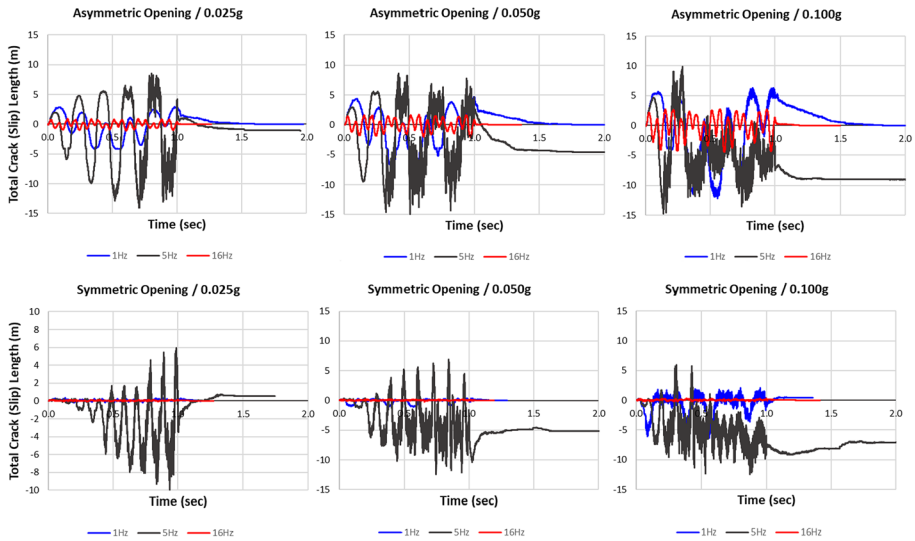
**Fig. 12** Total crack (joint slip) length in the wall model with asymmetric opening (top), and symmetric opening (bottom) for sinusoidal acceleration waveform of 0.025 g, 0.05 g and 0.10 g amplitudes (solid wall results are not presented here because the model did not provide any meaningful results in terms of crack length)

The discrete-element analysis results are presented in Fig. 12. The results were processed with respect to the overall wall top displacement in the lateral loading direction, joint slip and joint opening. The complete set of plots cannot be presented here due to lack of space. A consistent

Joint slip and joint opening are two ways proposed here for measuring the damage in URM. The damage can be more clearly quantified by using crack geometrical properties via these two metrics. Joint slip plots, shown in Fig. 12, provide residual slips up to 10 m total length in the entire wall. These are sliding movements, that would be manifested in an actual wall as cracks. Joint slip in the numerical model is sliding of a joint above others, as happens in the case of shear failure of the bed joints. The largest crack lengths, as well as residual cracks, occur in the case of 5 Hz loading because the frequency of the loading coincides with the natural in-plane frequency of the wall model with openings. Asymmetric or symmetric openings present little difference in total maximum and residual joint slip. It should be noted that the joint slip can take negative or positive values, as sliding motion can be in the positive or negative direction in respect to the original position of a given node. As observed in Fig. 12 the cracks open and close while the total crack length oscillates during the shaking. The ratio of the maximum total crack length to the residual total crack length increases drastically as the acceleration amplitude increases. The ratio of the maximum total joint slip to the residual total joint slip is 14.0 (14/1), 3.0 (15/5), and 1.67 (15/9) for 0.025 g, 0.050 g and 0.100 g acceleration amplitudes at 5 Hz, respectively, in the case of wall with asymmetric opening. The max to residual crack length ratio dropped from 14 to 1.67 (8.2 times) while the acceleration amplitudes increased only 4 times. It should be noted that the joint slip values for the solid wall were not meaningfully large and thus not reported here.

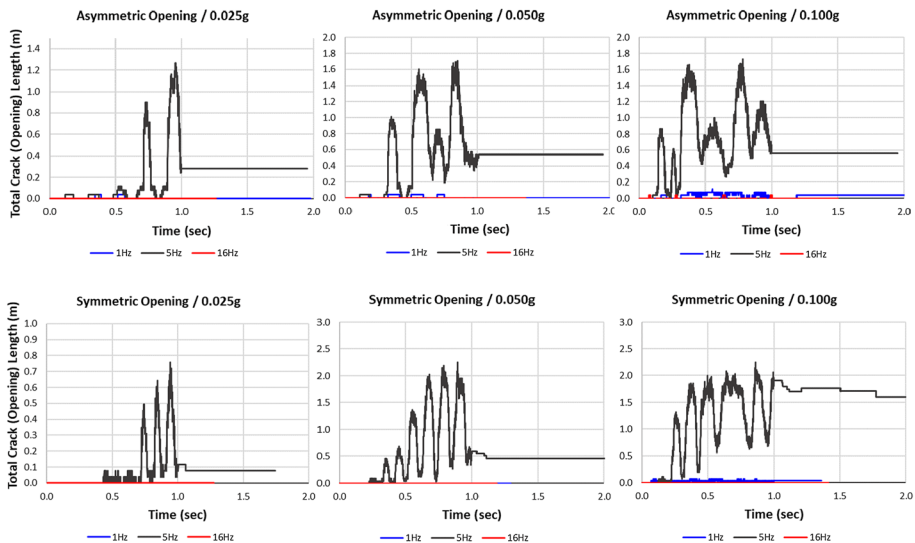
**Fig. 13** Total crack (joint opening) length in the wall model with asymmetric opening (top), and symmetric opening (bottom) for sinusoidal acceleration waveform of 0.025 g, 0.05 g and 0.10 g amplitudes (solid wall results are not presented here because the model did not provide any meaningful results in terms of crack length)

The results for joint opening are presented in Fig. 13. Similar to the joint slip results, the total crack lengths are much higher in case 5 Hz load is applied. The joint opening values presented are only positive, which represents the opening of a crack (i.e. negative values would mean units penetrating to each other). The ratios of the maximum total crack opening to the total residual crack opening are 5.2 (1.30/0.25), 3.1 (1.70/0.55) and 2.90 (1.75/0.60) for the wall with the asymmetric opening for 0.025, 0.050 and 0.100 g acceleration amplitudes at 5 Hz, respectively. Joint opening is a metric that is expected to be heavily influenced by rocking, a mechanism that dominates in the case of wall with openings. This is because of the slender piers formed on the two sides of the opening. Once the

rocking mechanism develops and the joint opening cracks are generated, the total crack length does not increase considerable when the acceleration amplitude takes higher values. Therefore, the ratio of the maximum total crack length to the total residual crack length does not practically increase when the acceleration loading amplitude is increased from 0.050 g to 0.100 g. This finding suggests that the joint slip and joint opening are two distinct metrics that need to be monitored individually because of the expected influence of the damage mechanism of the wall on the type of crack.
